VAN'S AIRCRAFT

SERVICE BULLETIN 18-03-06

Subject: Replace the throttle return springs

Affected Models: RV-12 (Powered with Rotax 912ULS)

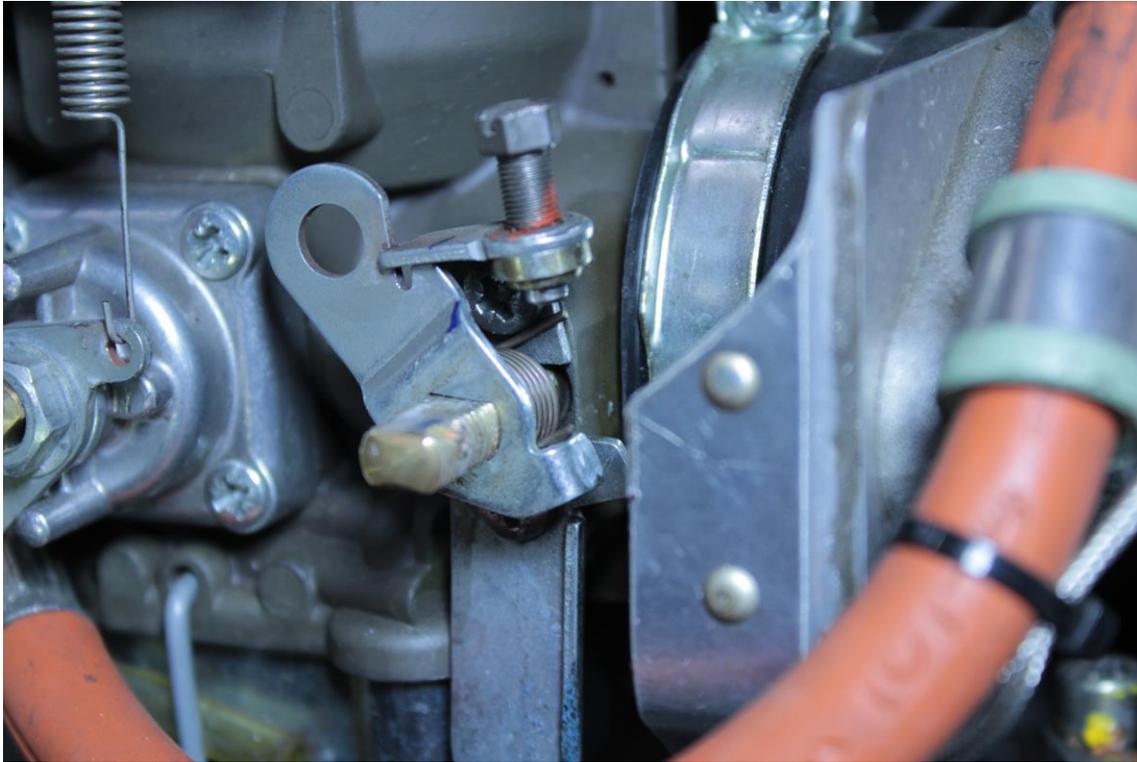
FIGURE 1: SPRING INSTALLATION (THROTTLE ARM NOT INSTALLED)

Replace the existing throttle springs with SPRING-00002-L/R-1. The previous spring was failing prematurely (before the recommended 100 hour replacement interval) on some aircraft.

Step 1: Remove SPRING-00002 as shown in KAI Section 50. See Figure 1 for reference.

Step 2: Install SPRING-00002-L/R-1 as shown in KAI Section 50.
