**VAN'S AIRCRAFT**  
TOTAL PERFORMANCE

## SERVICE BULLETIN 19-03-22

**Subject:** Cracking of the EX-00017 Cylinder #2 Exhaust

**Affected Models:** RV-12 with 912 ULS engines

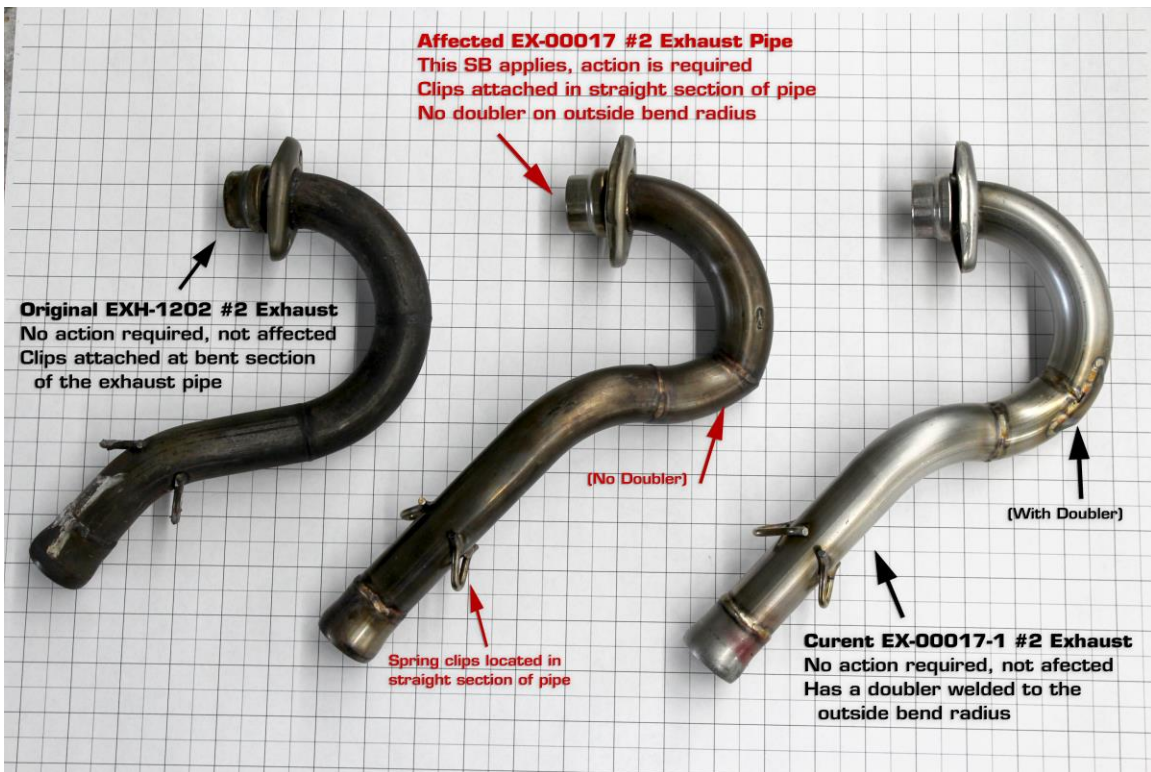
**Figure 1: Cylinder #2 Exhaust Variants**

Step 2: Inspect the cylinder #2 exhaust to determine which part number is installed. See Figure 1.

- If an EXH-1202 or EX-00017-1 is installed, proceed to Step 8.
- If an EX-00017 is installed, proceed to the next step.

**Required Action:** Inspect the EX-00017 Cylinder #2 exhaust tube for cracks as described in this document. If cracks are found, replace the EX-00017 with an EX-00017-1.
