SERVICE BULLETIN 14-11-03

Subject: RV-12 wing skin/spar flange rivet wear.

Affected Models: All flying RV-12 aircraft incorporating wing kits shipped prior to December 24, 2014.

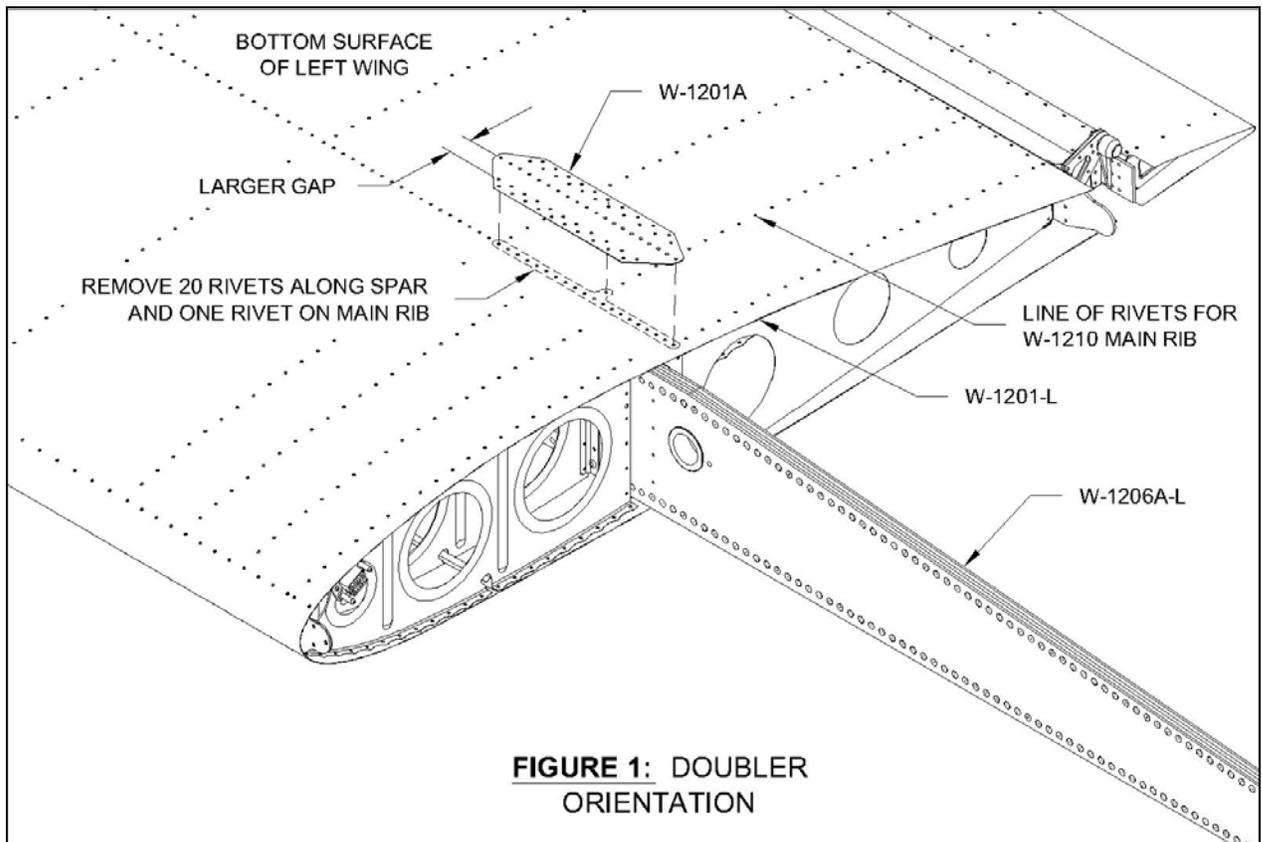
FIGURE 1: DOUBLER ORIENTATION

Step 3: Carefully remove the inboard 20 rivets attaching the W-1201-L Inbd Wing Skin to the flange of the W-1206A-L Spar Assembly and the single indicated rivet attaching the skin to the W-1210 Main Rib. See Figure 1.

Step 6: Cleco the W-1201A Doubler, oriented as shown in Figure 1, to the skin and spar flange with the larger gap between rivet rows forward, and with the hole for the main rib aligned with its corresponding hole in the doubler.

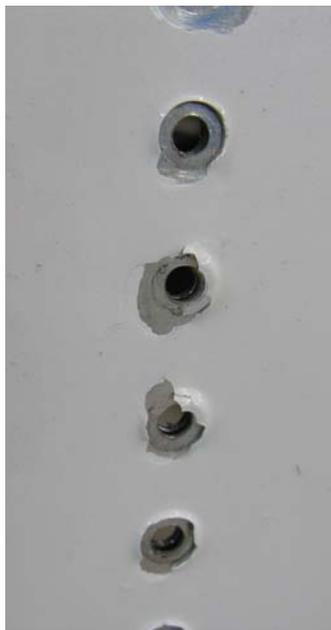
FIGURE 2: RIVET HEAD
PAINT BUILDUP

Step 5: Once the rivet heads are removed, any remaining paint buildup caused by the rivet heads must be removed. This can be done by shaving them flush with a sharp wood chisel, sanding them with a small sanding block, etc. See Figures 2 and 3.

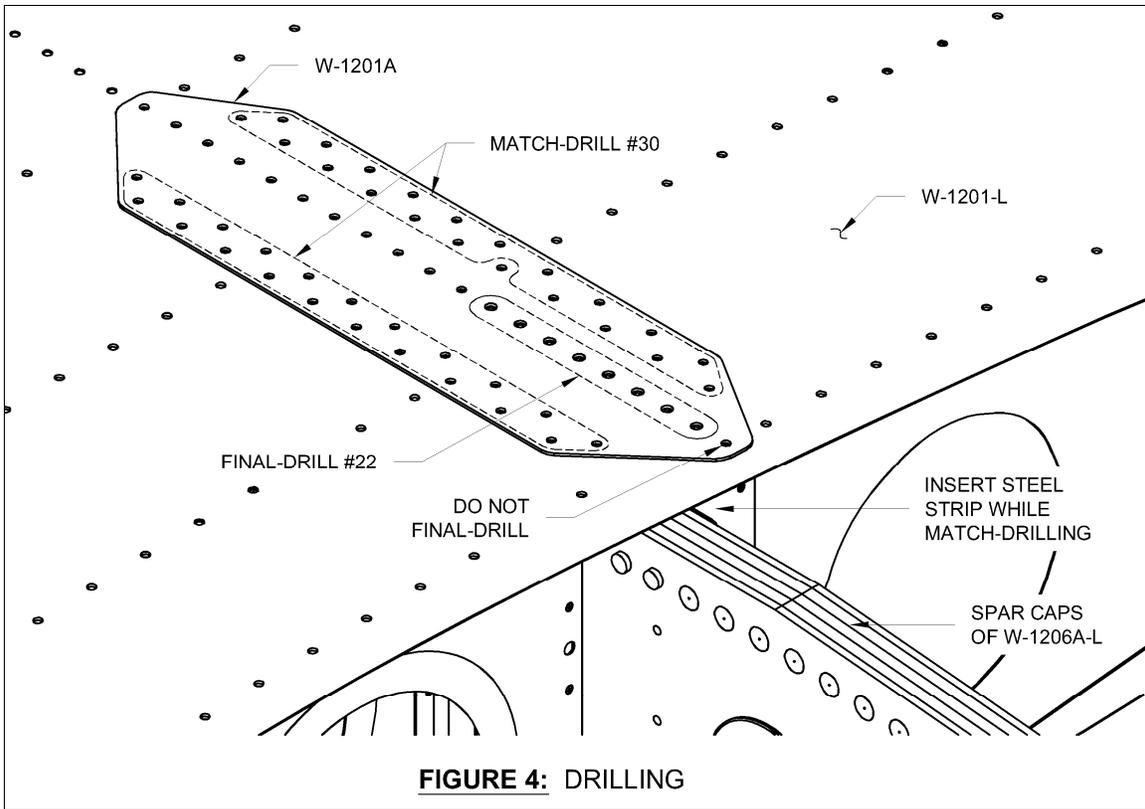
Step 7: Match-Drill #30 all of the remaining holes of the doubler into the skin. Cleco every second or third hole while drilling. See Figure 4.

Step 8: Final-Drill #22 the eight holes indicated in Figure 4 that are common to the doubler and to the flange of the spar assembly. As indicated, do not final-drill the inboard most hole.

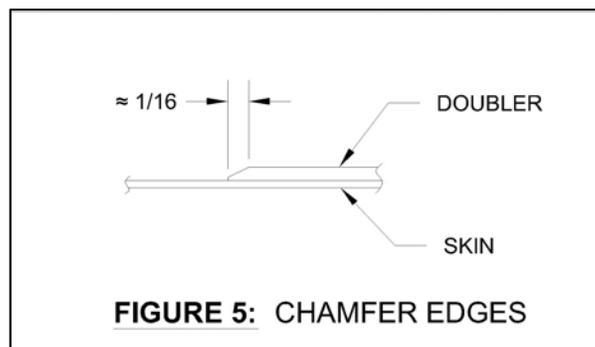
Step 10: Chamfer the perimeter of the doubler. See Figure 5.

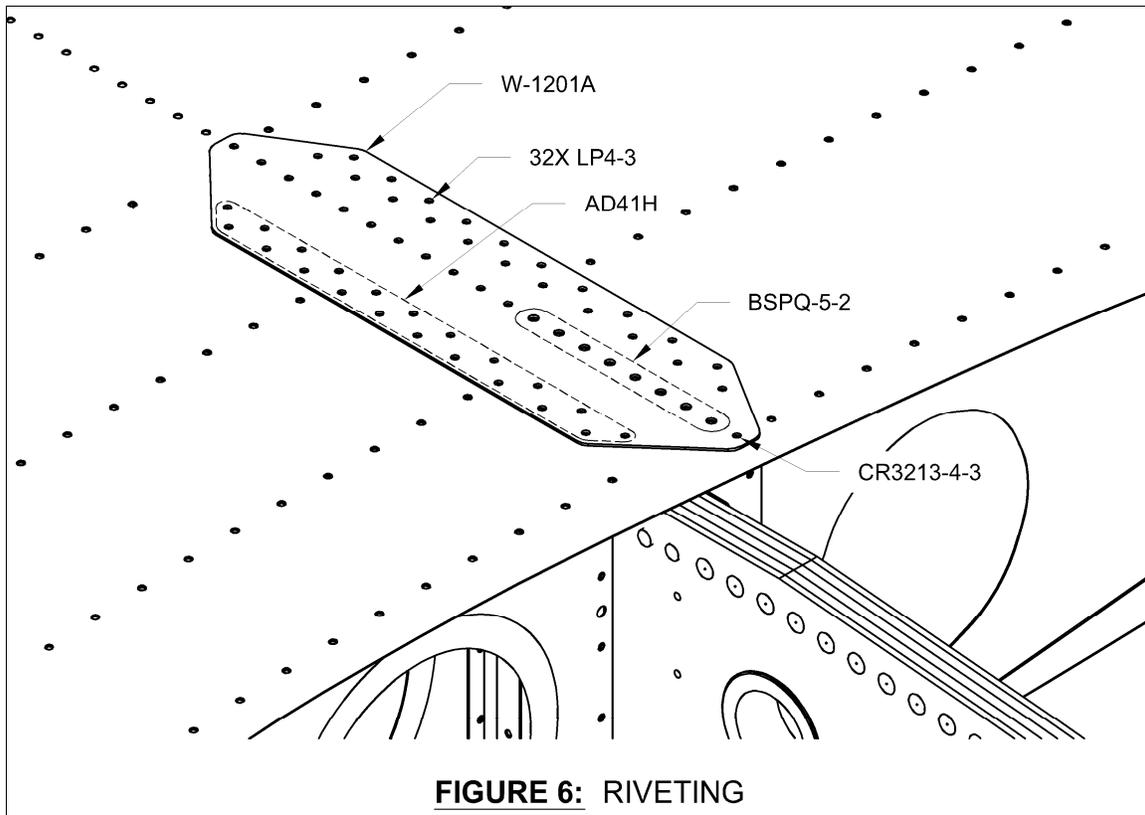
FIGURE 6: RIVETING

Step 12: Rivet the doubler to the skin and to the flange of the spar assembly using the rivets called out in Figure 6.
